FHWA/IN/JTRP-99/4

Final Report

**EMBANKMENT WIDENING DESIGN GUIDELINES
AND CONSTRUCTION PROCEDURES**

September 1999

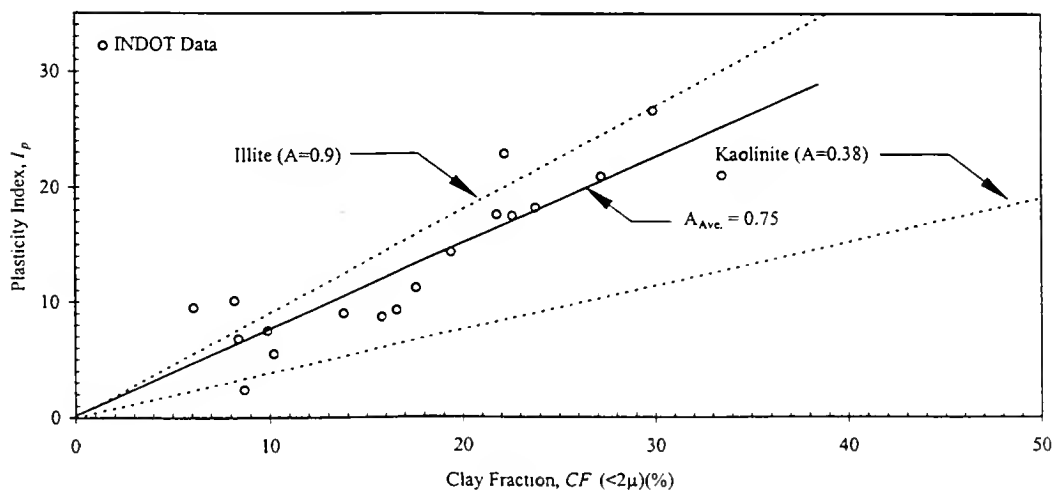
Figure 4.3. Activity of embankment soils, I-69, Madison County, Greenfield District.

A post-failure investigation was performed by INDOT. The field work was performed between December 1994 and March 1995. As part of this investigation seven borings were advanced and split-barrel samples were collected. Index tests, including grain size distribution, hydrometer and Atterberg limits analyses were performed on select split-barrel samples. The index test data has been summarized in Figures 4.2 and 4.3. As indicated by the index test data, the soils in the original embankment and those used to steepen the sideslopes are primarily low plasticity, fine grained soils, classified as CL in accordance with the Unified Soil Classification System. The activity, *A*, of these soils is approximately 0.75 on average, indicating that illite is the primary clay mineral.

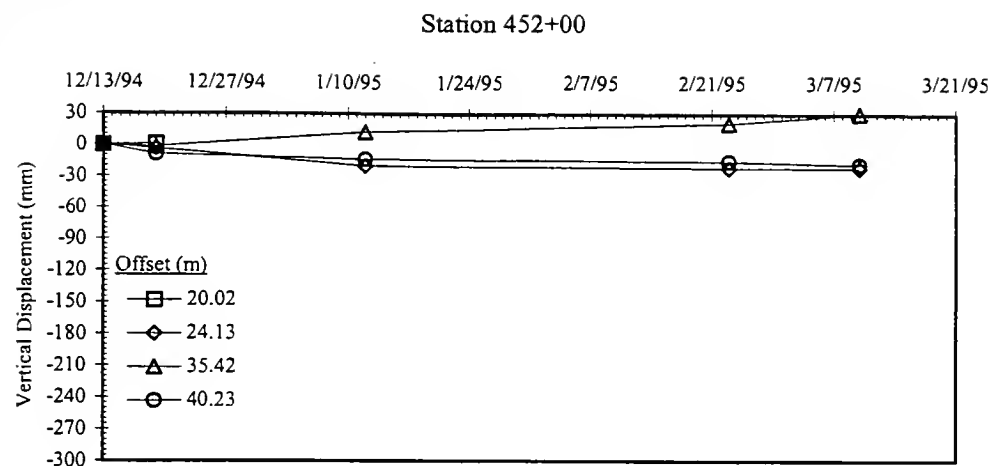
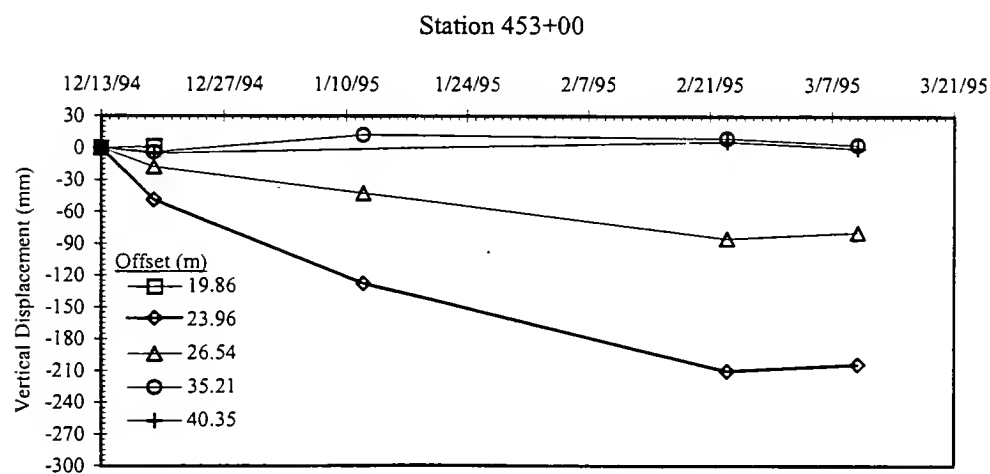
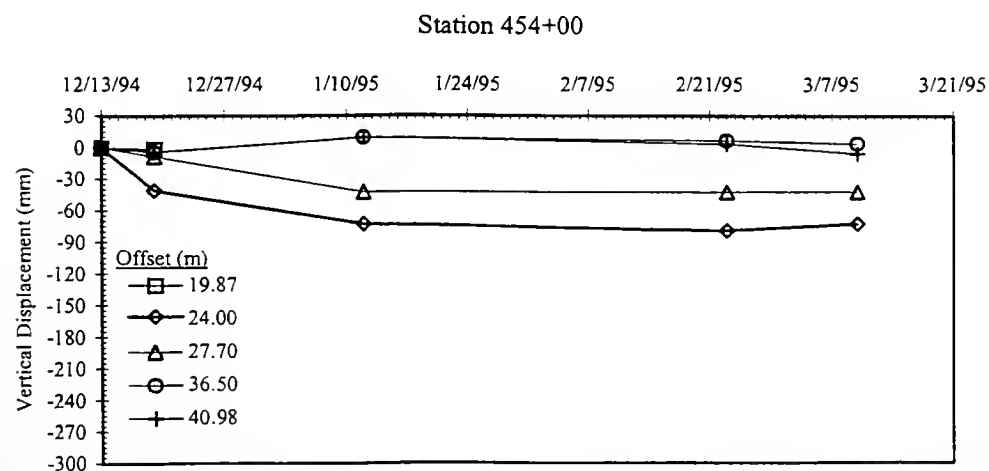
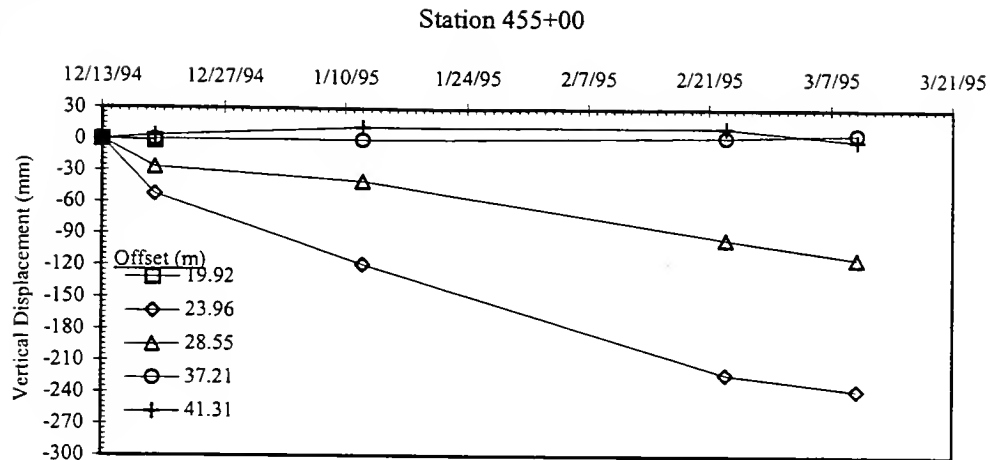
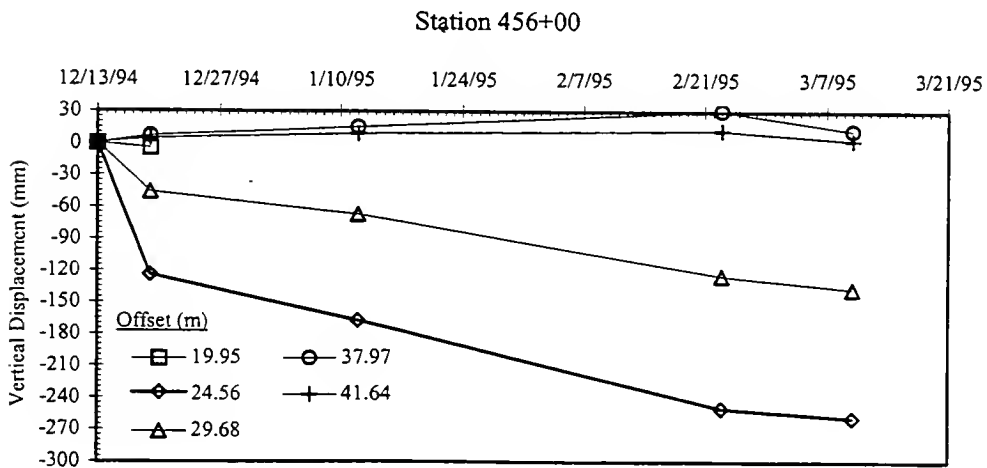
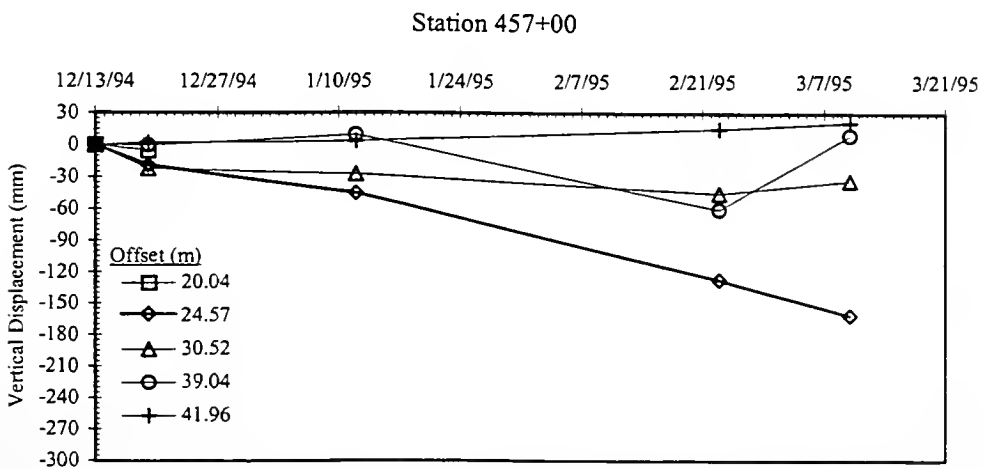
Figure 4.8. Vertical deformation data, I-69, Madison County, Greenfield District.

Vertical and horizontal deformation was measured by INDOT and is presented in Figures 4.8 and 4.9, respectively. Review of vertical deformation data reveals that the greatest settlement occurred in the sideslope, near the shoulder of the road and decreased with increasing distance from the centerline of I-69. No vertical displacement was noted at the toe of the embankment or beyond.
